SUMMARY

GARN® Technical Service Bulletin: Potentially Defective Anode Rods

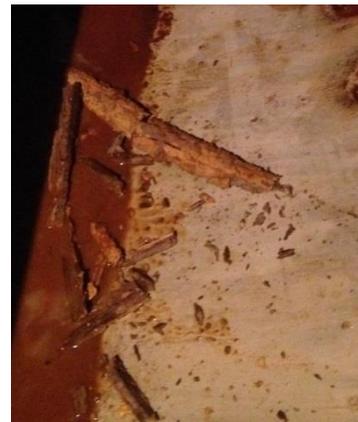
The rod material then falls to the bottom of the tank:

Figure 5: Sloughed Rod Material on Tank Bottom

2. After the rods are removed, plug the holes with a $\frac{3}{4}$ " NPT plug. If only the steel core remains on the rod, the rod can be used as the plug.
3. **Remove any and all anode rod debris on the bottom of the tank using the swimming pool leaf rake (or other method).**

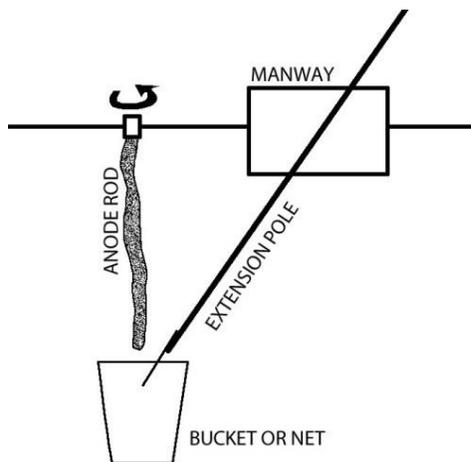
Figure 6: Place a Bucket/Net Underneath Anode Rod When Removing the Rod

1. When removing the rods, please catch the *slough/debris* that falls off the rod instead of letting the rod debris fall to the bottom of the tank. A simple method for doing this is to buy a pool leaf rake with extension pole from a local retailer and have a helper hold the net underneath the anode rod as it's removed. Another method is to attach bucket to a handle/pole:

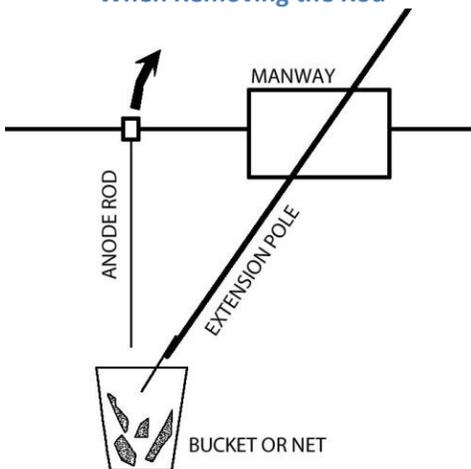
Figure 7: Catch the Anode Rod Debris and Remove the Rod

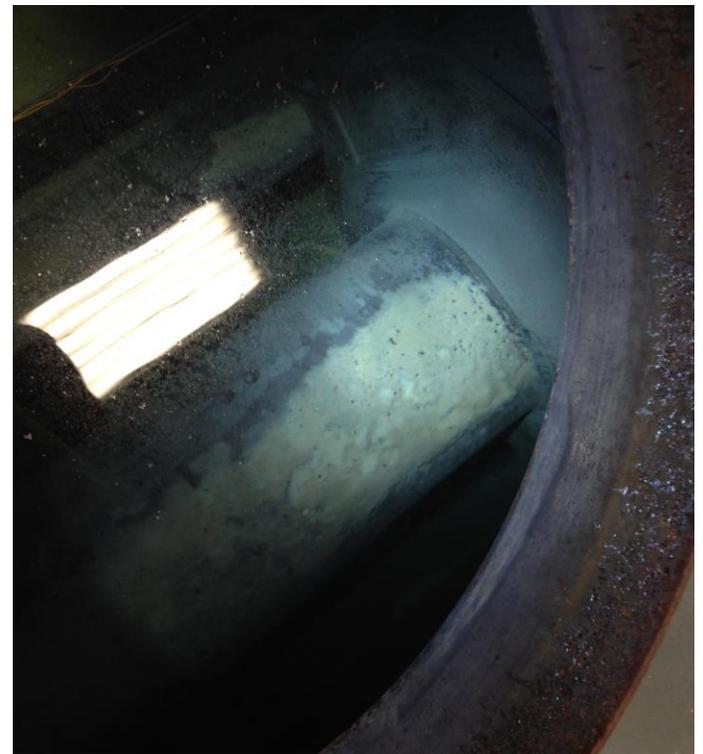
Figure 8: White Fluff on top of Reaction Chamber Tubing. Picture taken from manway access with unit filled.

Customers with anode rods exhibiting this issue may experience a white fluff that appears as a "cloud" on the bottom of the tank and on the heat exchanger tubing. For customers that have this condition, Dectra is recommending that the fluff be siphoned out. Use a standard garden hose and wand capable of reaching the problem areas and siphon as much of the fluff out as possible. If needed, top off the unit with filtered, clean fill water from the original fill source.

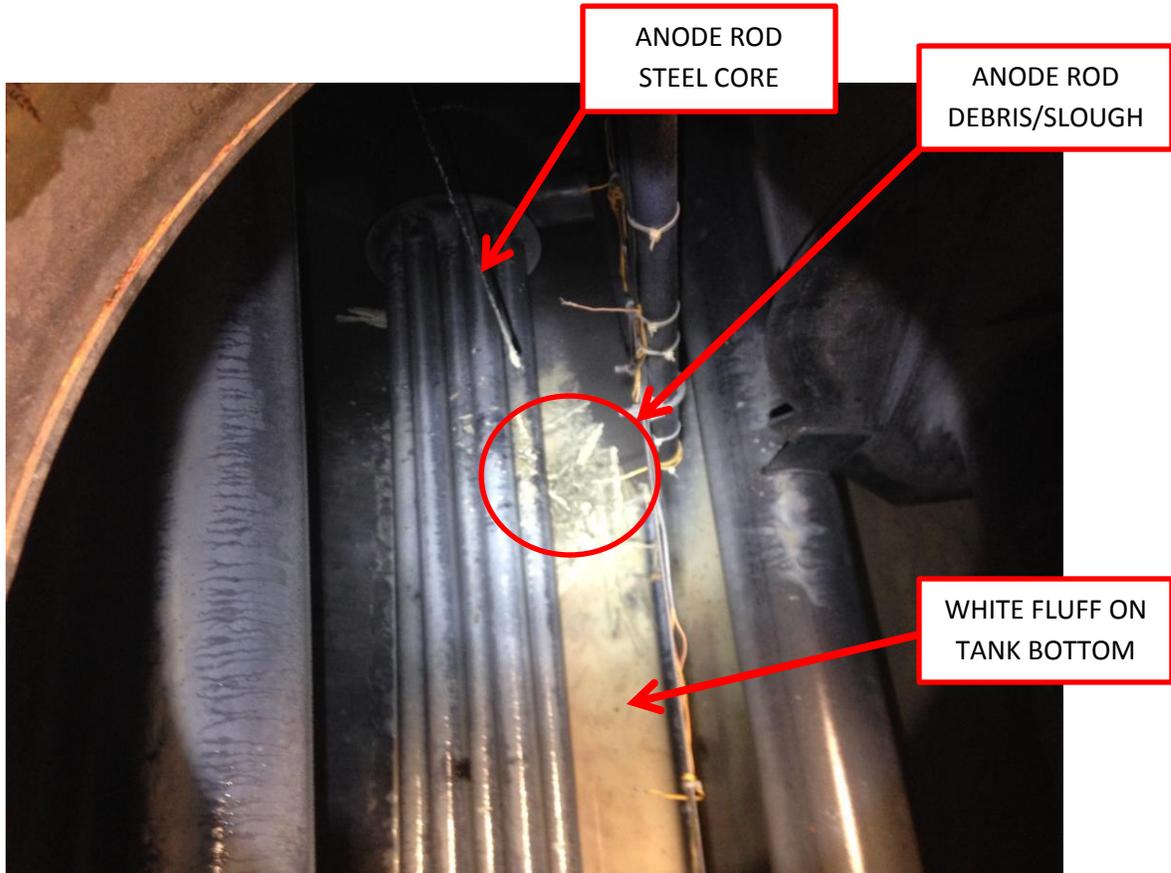
Figure 9: White Fluff and Anode Rod Debris on Tank Bottom. Picture taken from manway access after unit was drained
