## Testing, Testing, Testing . . .

As a result of the previous GARNews® discussion about EPA and ASTM test methods, some GARN® supporters are wondering about the status of GARN WHS testing. Therefore, this month's GARNews provides a sneak preview of the *updated and upgraded* GARN test lab that is dedicated to that specific function.

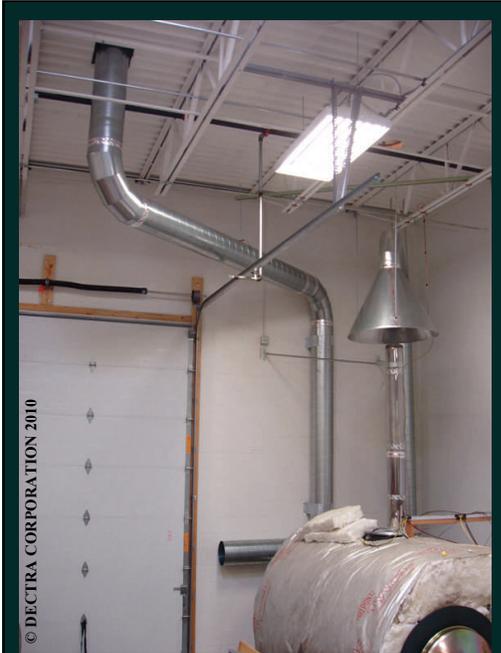
*This is an overall view of the hood and duct of the dilution tunnel. The exhaust fan is located on the roof.*

- The dilution tunnel hood, duct supports and fan system was designed. Computer analysis confirmed proper flow and static pressure drop.
- Duct and fan components were purchased and the system erected. The fan is roof mounted so does not show in the pictures below.

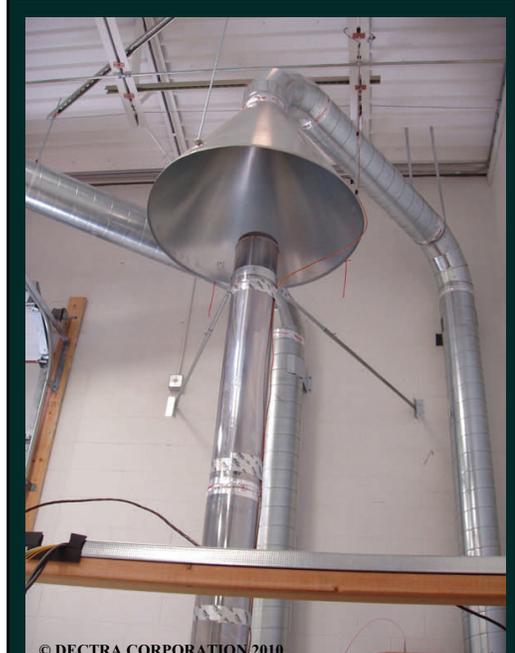
*A closer view of the dilution tunnel hood and duct.*

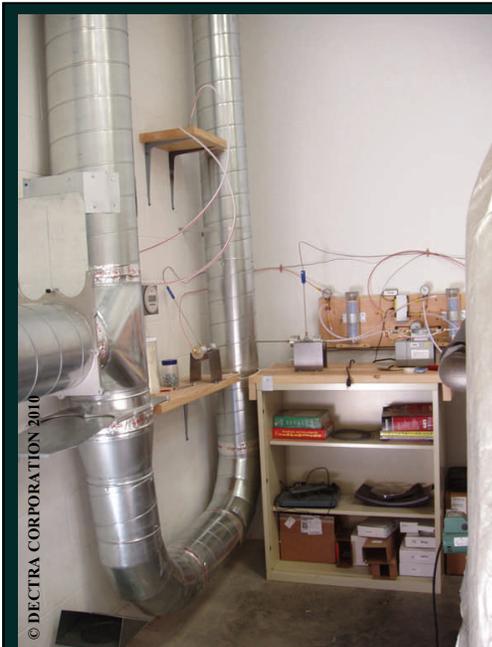
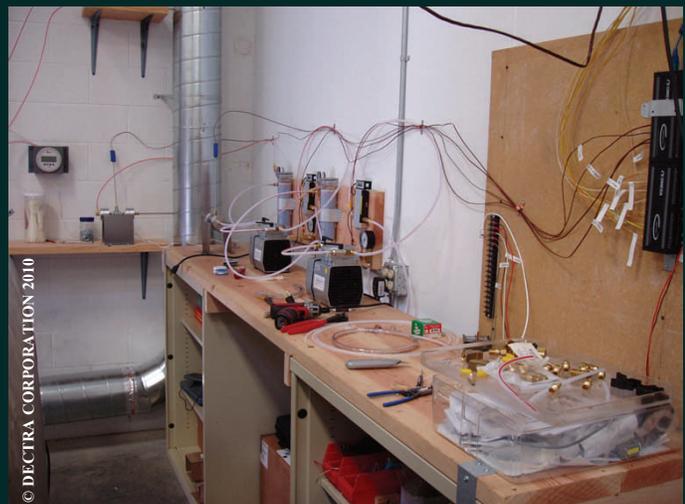
*The vacuum pumps, dryer columns, filter housings, gages, thermocouples, flow meters, etc. required for testing. Additional thermocouple wiring and vacuum line work remain. The existing computer system is being utilized for data collection and analysis with this new equipment. The test setup should be complete and debugged shortly.*

- Test instrumentation was specified and ordered. All key instrumentation is certified compliant with NIST (National Institute of Standards and Technology).
